DIAGNOSIS OF EXISTING STATE AND STRENGTHENING SOLUTION FOR 180 M HIGH REINFORCED CONCRETE CHIMNEY

V.Micov, L.J.Tashkov & L.Krstevska R.Salic & G.Jekic
*Institute of Earthquake Engineering and Engineering Seismology, (IZIIS),
"Ss. Cyril and Methodius" University, Skopje, Republic of Macedonia*

The present paper deals with the procedure for diagnosis of the existing conditions of the bearing structure and a solution for strengthening and repair of 180 m. high reinforced concrete chimney of the thermal power plant Oslomej, Republic of Macedonia.

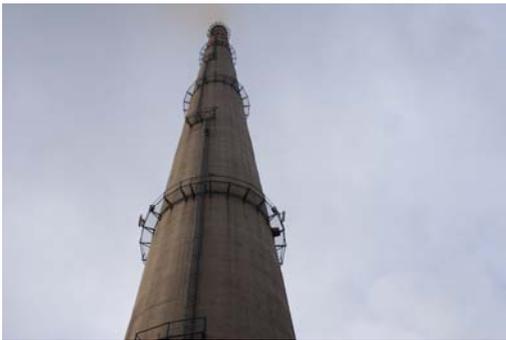
Figure 1. View of the chimney along height

A procedure for diagnosis of the existing conditions of the bearing structure of a 180 m high reinforced concrete chimney of the thermal power plant “Oslomej” in Oslomej, Republic of Macedonia, has been defined. Analytical study of the conditions of the chimney has been performed as well as the needs and the effects from strengthening and repair of the structure have been presented. The chimney of the thermal power plant “Oslomej” represents a reinforced-concrete structure with a circular cross-section, variable thickness and a height of 180 metres, Fig. 1.

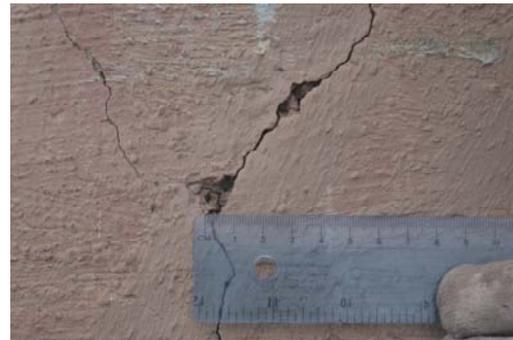
Figure 2. Vertical and horizontal cracks in the external wall at level + 90,00

The complete osculation of the structure showed existence of a large number of micro-cracks in horizontal and vertical direction as well as mesh like cracks. The cracks were observed and their dimensions were defined at a distance of about 2 meters. The opening of the cracks is visible and ranges from 0.1 mm to maximal values of 1-2 mm. At several places, open caverns with blowing ash coming from inside, are observed.

The damages in the form of cracks extend from the height of 90 m to the highest point of the chimney. The cracks are the most pronounced (per length and width, Fig. 2) in the middle of the chimney, at the height of 85 to 95 meters. With the performed osculation of the lower part of the chimney structure up to the height of 85 meters, no damage or important cracks were observed on the external wall.

With the repair of the structure, injection of all the observed cracks is anticipated to be carried out by injection mixtures based on cement mortar with additives for fluidity, increased strength characteristics and adhesion with the base. The same can be done also by filling the cracks with epoxy resins. The designed strength characteristics of the injection mixture have to be proved by testing of trial prisms proportioned 40 mm x 40 mm x 160 mm. The injection should be done in all the detected cracks, particularly in the zones starting from 85 metres to the top of the chimney.

With the injection, a compact connection is achieved between the concrete and the mixtures so that good strength and deformability characteristics are achieved at the well injected places of the structure.

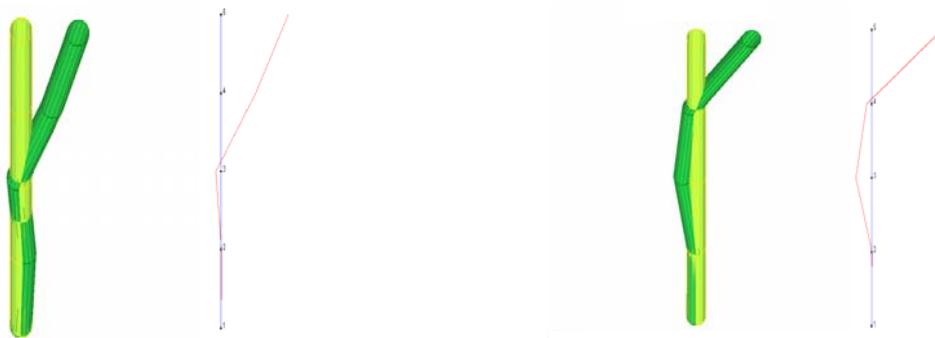
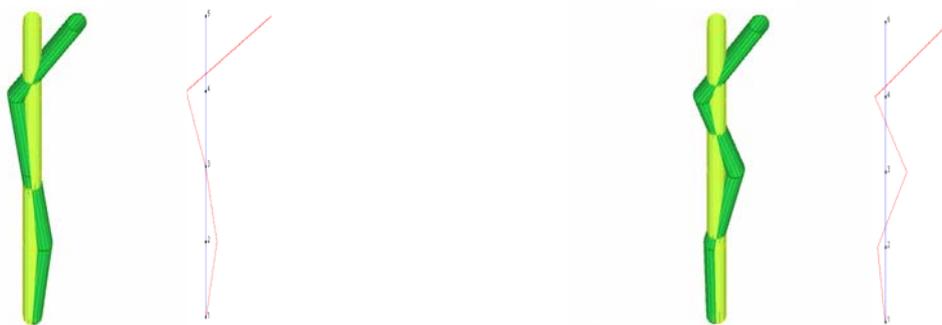
The mode shapes of vibration for the corresponding natural frequencies are shown in Fig. 7 and Fig. 8 - spatial and linear presentation. In this way, a clear insight into the vibration modes of the chimney is obtained and used as a basis for concluding the following:

- ◆ The vibration shape at the first natural frequency of the chimney $f = 0.29$ Hz points to deviations from the usual and expected shape of the first mode for such type of structures – high and slender RC chimneys, i.e., that there is a certain discontinuity in stiffness at the level above the second platform. This is also pointed out by the amplitudes of the mode shapes that are considerably high at the level of the third and the fourth platform, i.e., the upper part of the structure, expressing in this way, the so called “ whip effect”;

- ◆ Although there is expected distribution of zero points along vertical line in the vibration shapes at the second, the third and the fourth mode, the “whip effect” still clearly points that, above the second platform, the chimney has increased amplitudes of vibration that most probably result from the existing and visible cracks in that part of the structural height as well as crushing of concrete and penetration of aggressive gasses that pass through the chimney, which was observed in some zones of the upper height, between the third and the fourth platform.

- ◆ To confirm the above statement, analytical simulation of a model with an incorporated plastic hinge at the level above the second platform was performed. The analytically obtained mode shapes compared with the experimentally defined ones show good agreement, which points out that the assumption about the existence of such a hinge is realistic.

Figure 7. Vibration shape at $f = 0.29$ Hz and $f = 1.07$ - experimental

Figure 8. Vibration shape at $f = 2.44$ Hz and $f = 4.49$ Hz - experimental
